Summary

In order, the top three consumables of an FTIR are the desiccant, IR source, and HeNe laser.

Removing the old laser

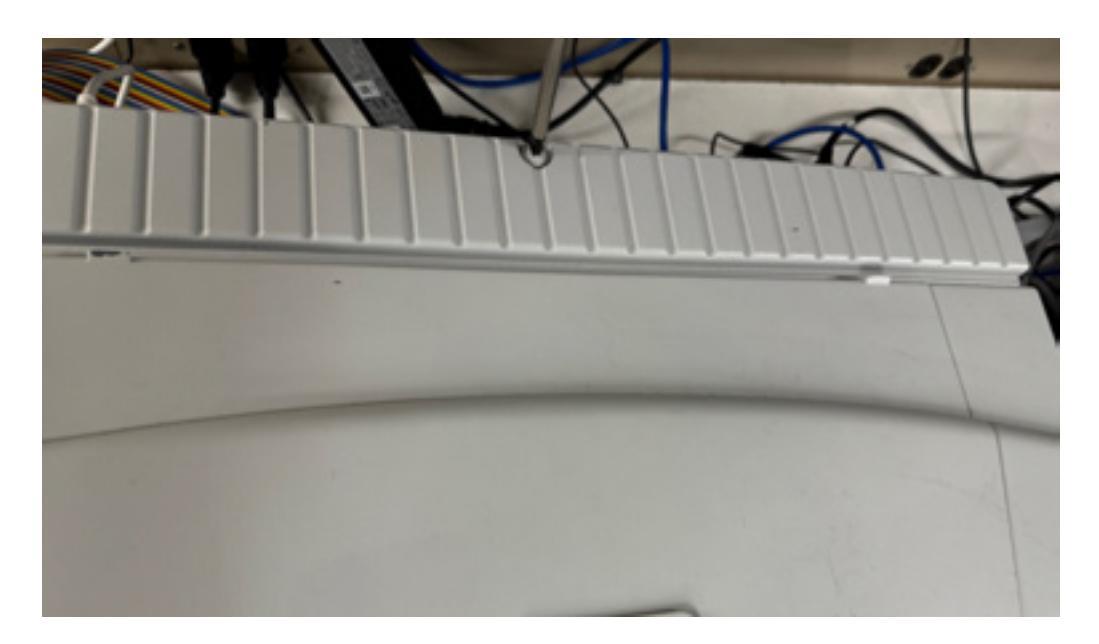
- 1. Turn off the FTIR.
- 2. Remove back Panel (single screw).

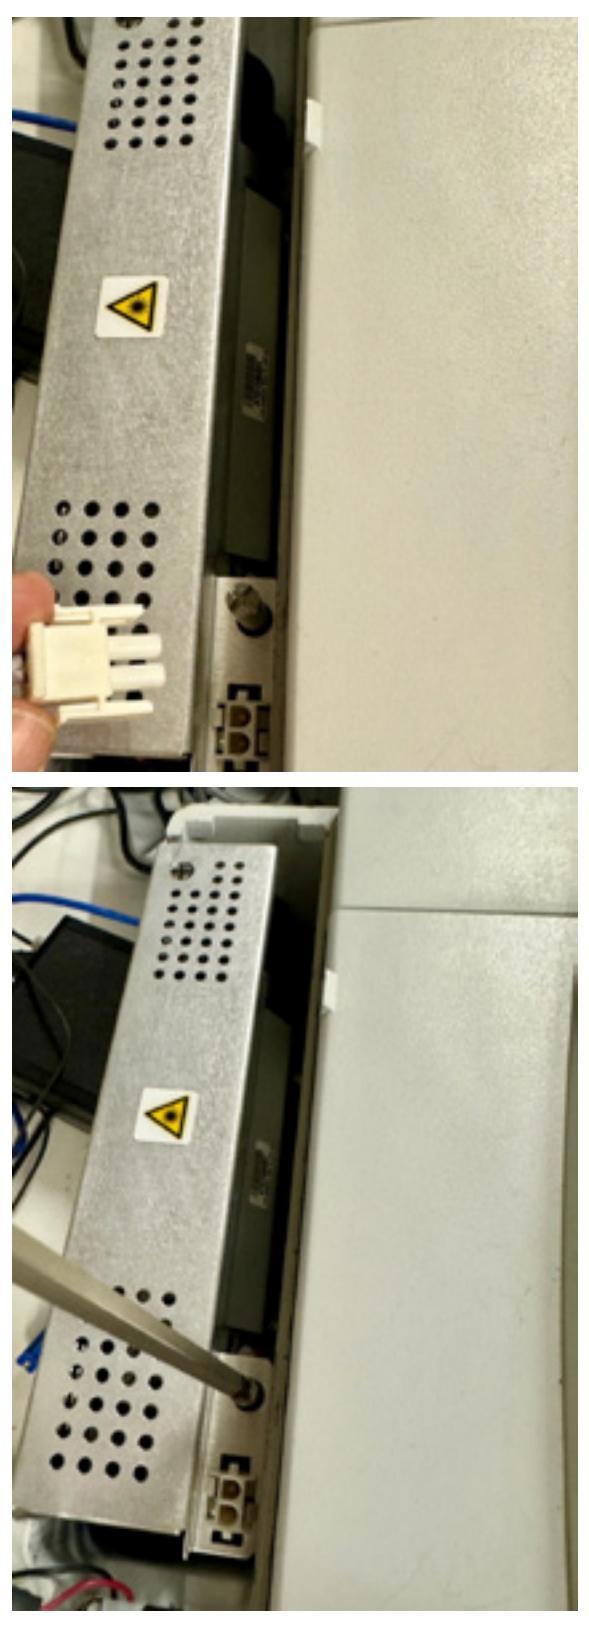
3. Unplug the laser power connector on the laser module.

4. Using a large Philips screw driver loosen screws, and pull module out.

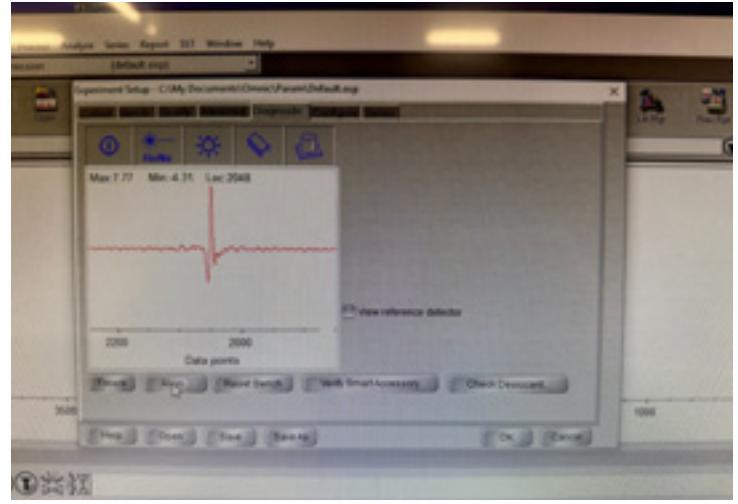
- 1. Remove tape on laser (protects the lens from dust/handling).
- 2. Reverse the same sequence as above in the removal process.
- 3. The laser can only go in one way. On the bottom side of the module there are dowel pins that assure the laser will be seated for proper alignment.
- 4. Power the FTIR up.
- 5. Open the Omnic Application.
- 6. Go into Experiment Setup, then the Diagnostics tab.
- 7. Hit Align and verify the alignment has completed.
- 8. When the alignment is complete you should see an interferogram of some amplitude as shown to the right.
- 9. Exit Omnic and go into Local Disk C
- Program Files->Omnic->

and run the application called
 "BenchStatusReport (Running this status report application will report all settings in a TXT file

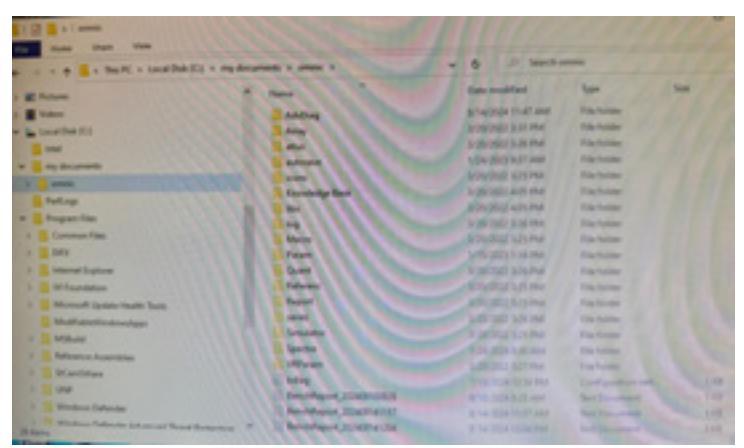
11. Go into My Documents.

12. Look for the latest Bench Report.

Note: all of the Laser gain values should ideally be less than 100 with a new laser. You can use this report for future reference for other settings as well. This report is often used by Thermo Tech support for diagnostics on the instrument.
